Medical Device Alert

Ref: MDA/2011/060 Issued: 02 June 2011 at 11:00

Dual Chamber Pacemakers.

Dual Chamber Pacemakers with Measurement Lock-up ERI

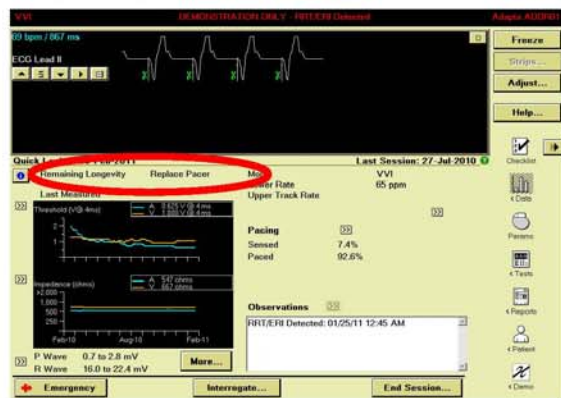
Example 1 – Programmer Screen for Typical Pacemaker at ERI

Two examples of images from the Medtronic 2090 programmer are shown below. Example 1 shows what a normal ERI condition looks like. Example 2 shows what will be displayed if the ERI is triggered due to the measurement lock-up condition.

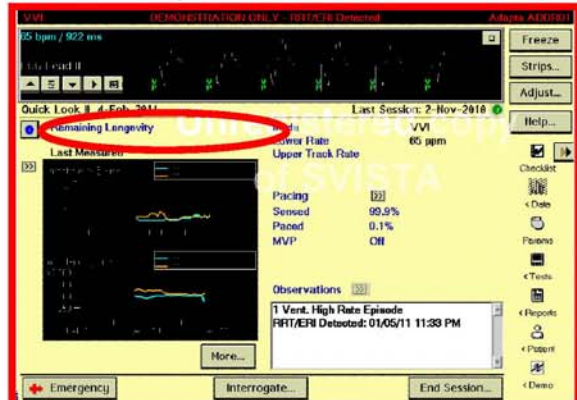
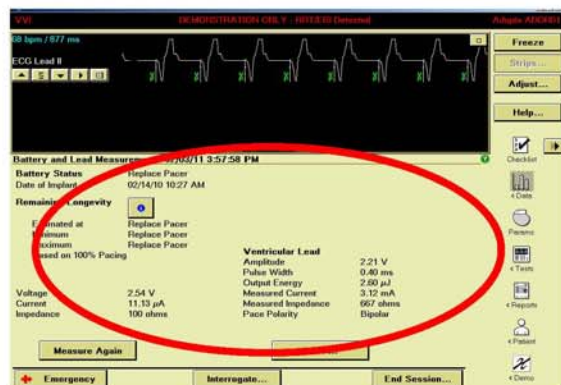
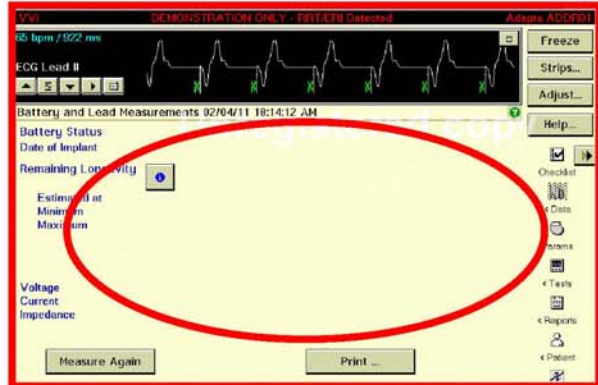
Example 2 – Programmer Screen for Measurement Lock-up ERI

If this rare measurement lock-up occurs in the pacemaker, it causes the device to read a value of zero for battery voltage. After four measurements of zero, the device will trigger ERI and revert to a VVI pacing mode at 65 bpm. There is no loss of ventricular pacing and the output voltage will remain the same.

The issue can be uniquely identified using the programmer or via CareLink transmission; the battery voltage measurements and remaining longevity will appear as blank values. Medtronic has developed a method for clearing the ERI condition through the use of a specially configured programmer. There is no impact to the device functionality or longevity after this reset is complete.

A device that has experienced a measurement lock-up ERI will present ALL of the following symptoms:

- Device declaring ERI/RRT
- Remaining Longevity = <Blank> on the programmer (and CareLink where available)
- Battery Voltage = <Blank> on the programmer (and CareLink where available)
- If the user attempts to take a Battery and Lead Measurement, a pop up window will indicate that it cannot estimate remaining battery life.

This condition can be reset and does not require device explant. If this measurement lock-up occurs, obtain a save-to-disk file and contact your local Technical Consultant or Medtronic Technical Services on 01923 212 213 for assistance. Reset devices are no more likely to experience a recurrence of this issue.
